A Study of Crankpin Failure in I.C. Engine

M. Senthil kumar¹, Dr.S.Ragunathan², M.Suresh³, V.R.Srinivashan⁴

A detailed study was carried out on crankshafts used in two wheeler made from C45 (EN 8/AISI 1042) steel. Undesirable noise was heard in crankshaft when the engine is in running. This was stated as failure of crankshaft. Material has been peeled off and seemed to be scraped at the central portion of the crankpin. It was the bearing seating place where oil hole also provided. Under analysis the crankpin was identified as tempered. Chemical composition, micro-hardness and microstructure were studied and compared with the specified properties of the crankpin material. Reason for failure is identified as wear due to lower hardness, improper lubrication and high operating oil temperature.

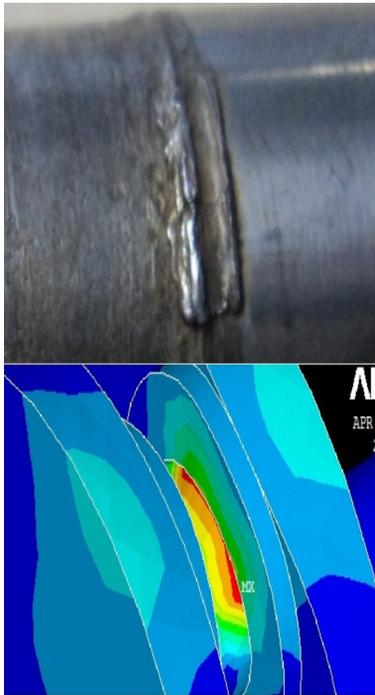
Fig.2. Stress concentration on fillet area

The original image of failed crankpin shows that the wear is maximum at the fillet region where the crank web contacts with the crankpin. And this region is considered as one of the critical locations. The same is validated in finite element analysis.

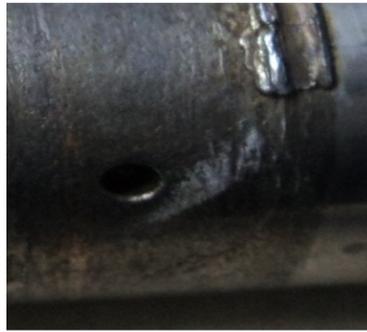
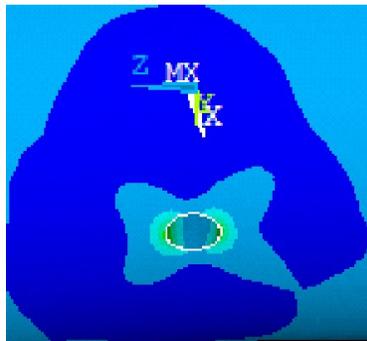
Fig.3. Stress concentration on oil hole

The original image of failed crankpin shows that the oil hole provided at the centre of crankpin for lubrication of connecting rod and connecting rod big end bearing. And this region is considered as one of the critical locations where the stress concentration will be more. The same is validated in FEA

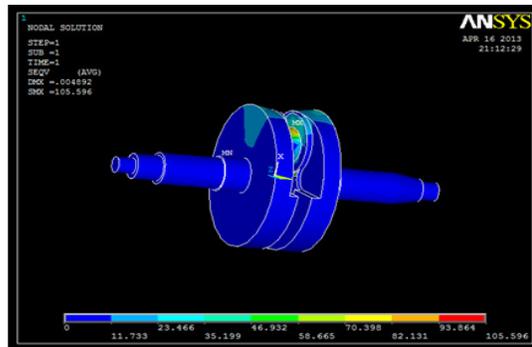
Fig.6.Finite element stress analysis of the crankshaft

Bearings are assumed as boundary conditions and their displacement is assumed zero. Force is applied from the crankpin bearing location for 120° angle of contact [12]. Vonmises stress in the failure location and fillet radius are higher and hence they are considered as critical location for the analysis.

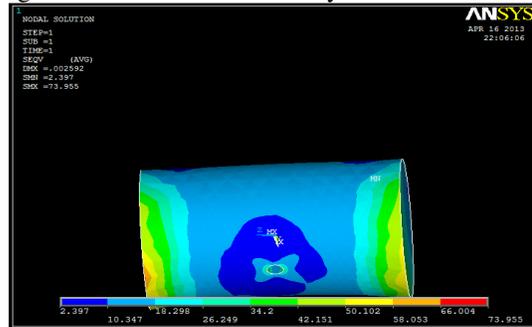
Fig.7.Finite element stress analysis of the crankpin

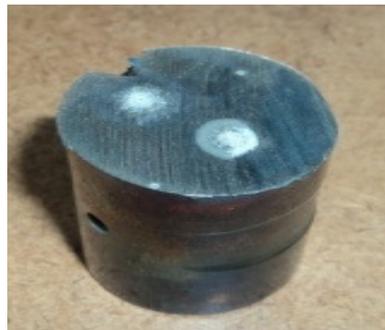
Fig.8.Crankpin

The crankpin was cut perpendicular to its axis to find out the chemical composition. Table.1 and 2 gives the specified chemical composition of crankpin material. In the same table the chemical composition of the material from the failed shaft and crankpin is reported by using Optical Emission Spectroscope (OES) analyzer. Analysis revealed that the crankpin material is SCM 420 and crankshaft material is EN 8 of BS 970(C45 steel). It is observed that the chemical composition of crankpin is within the specified range.

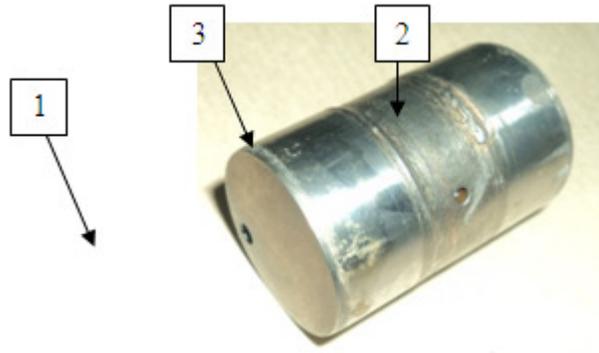
A failed crankshaft was analyzed for the cause of failure. When the crankshaft was taken from engine, it was found that crank pin was worn out severely and looked like material has been peeled off and scraped at the centre of the crankpin.

Fig.9.Failed crankpin

Hardness of the failed crank pin and a new crank pin was tested at both cross section side and centre of the crankpin around the circumference at different points by using Vickers micro hardness tester. The mean hardness value at the three locations (Fig.9) is listed in Table.4 and Table.5.

Hardness result shows that the failed region (centre of crankpin) has lower hardness than cross section sides and hence the wear was initiated earlier due to friction and it propagated due to improper lubrication with oil temperature.

However the hardness value at the failure region was lower (699 HV1) than other locations (716 HV1) and it is the cause for the rapid wear of the crankpin at the contact region. This initiation of failure is consequently propagated by improper lubrication. Hence the stress and wear at this region becomes more.

Then the crankpin central portion was subjected to selective induction hardening to the depth of 3mm followed by salt bath quenching [11]. The hardness measured after hardening is listed in table 6.
