A Study of Crankpin Failure in I.C. Engine

M. Senthil kumar¹, Dr.S.Ragunathan², M.Suresh³, V.R.Srinivashan⁴

A detailed study was carried out on crankshafts used in two wheeler made from C45 (EN 8/AISI 1042) steel. Undesirable noise was heard in crankshaft when the engine is in running. This was stated as failure of crankshaft. Material has been peeled off and seemed to be scraped at the central portion of the crankpin. It was the bearing seating place where oil hole also provided. Under analysis the crankpin was identified as tempered. Chemical composition, micro-hardness and microstructure were studied and compared with the specified properties of the crankpin material. Reason for failure is identified as wear due to lower hardness, improper lubrication and high operating oil temperature.

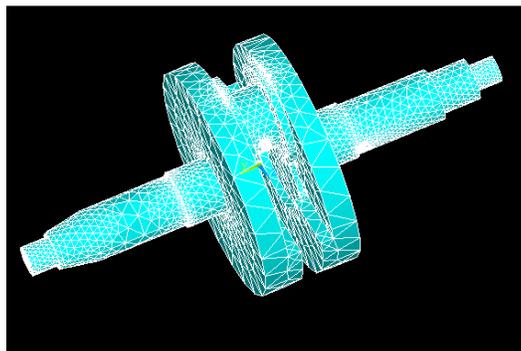
Fig.4. Meshing

The stress level of the failed crankshaft is analyzed by finite element method. Fig.4-7 gives the finite element model of crankshaft and shows us the stress results at the crankpin location. Crankshaft assembly and crank pin are analyzed separately.

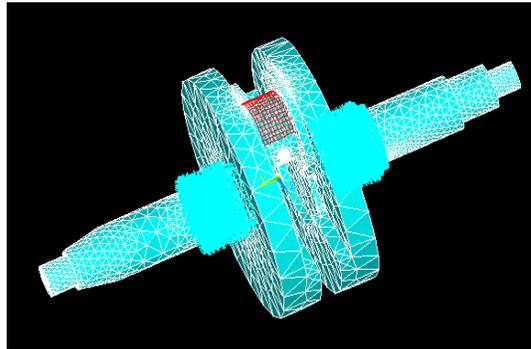
Fig.5. Boundary conditions

Bearings are assumed as boundary conditions and their displacement is assumed zero. Force is applied from the crankpin bearing location for 120° angle of contact [12]. Vonmises stress in the failure location and fillet radius are higher and hence they are considered as critical location for the analysis.
